SECTION 4. REPAIR OF METAL PROPELLERS

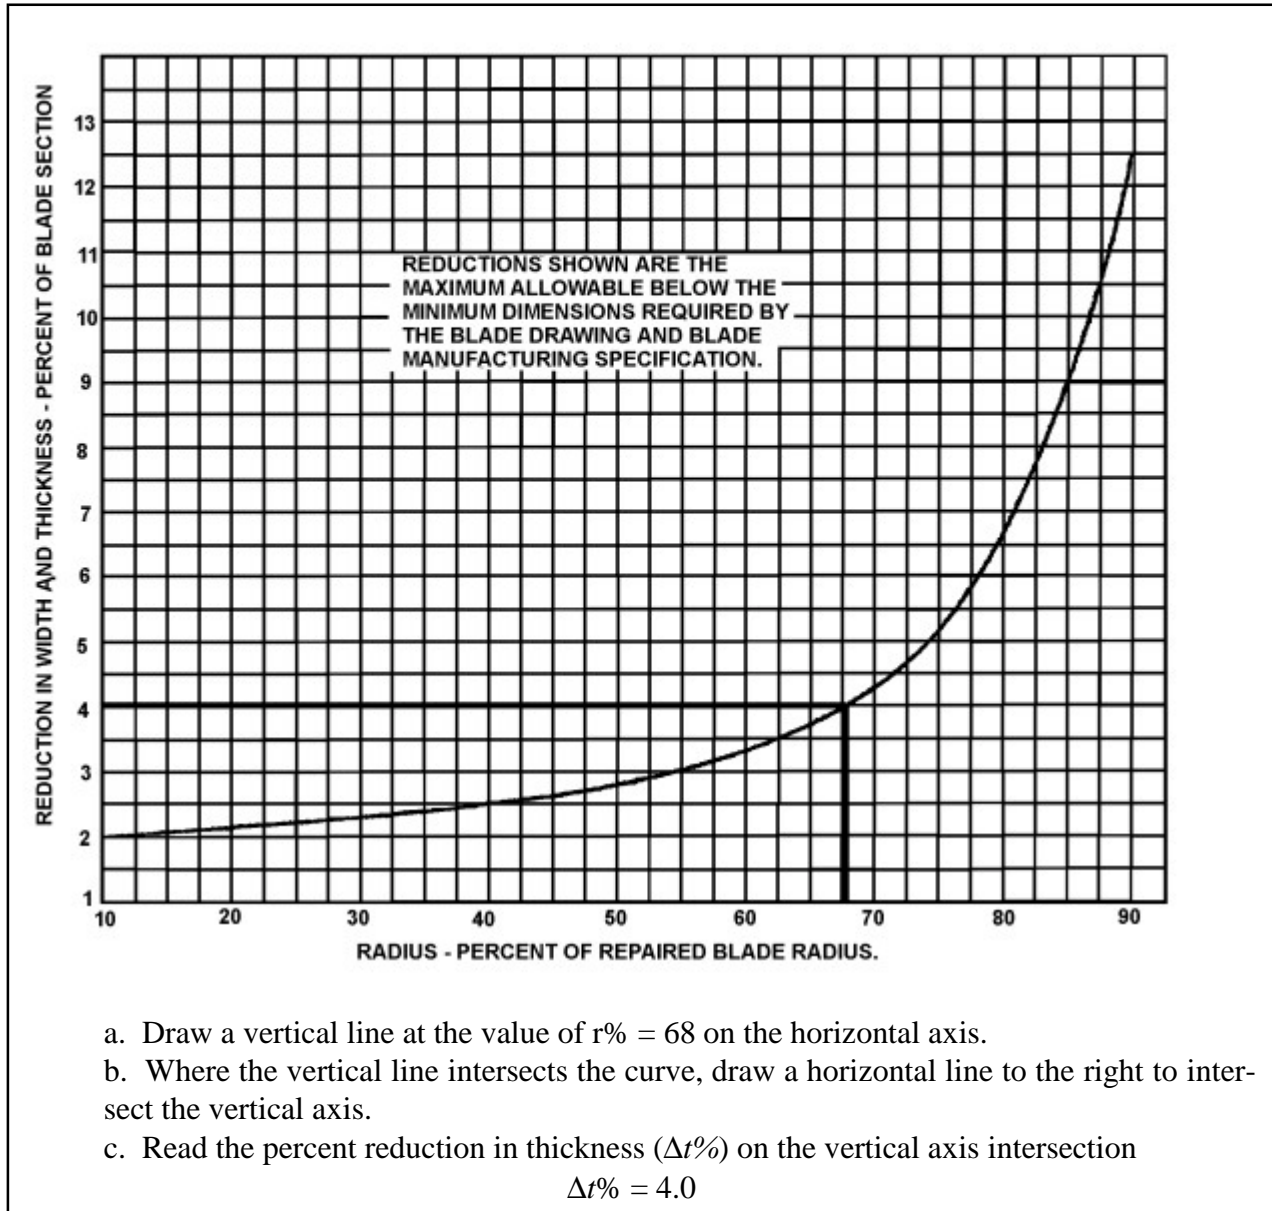
FIGURE 8-28. Example 2. Determine the repair thickness limits.

(2) Example 2. Determine the blade thickness repair allowable (Δt) and minimum blade thickness limit (t_1) for a blade having a diameter (d) of 10 ft. 6 in. The repair location (r_1) is 43 in. from the shank and the original, as manufactured, blade thickness (t) at the repair location is 0.07 in.

(c) Step 3. Determine percent reduction in thickness ($\Delta t\%$) from figure 8-28.

$$\Delta t = (\Delta t\%) \times (t) \times (0.01) = (4.0) \times (0.07) \times (0.01) = 0.003 \text{ in.}$$
